CLUSTERS OF CYCLONES AND THEIR EFFECT ON COAST ABRASION IN KALININGRAD REGION

Abstract: The shores of the Kaliningrad Region (the Russian part of the South-Eastern Baltic Sea) are regularly exposed to extreme storms, which leads to intensive abrasion and flooding of the land. Based on archival data, meteorological monitoring, forecast and synoptic maps, an analysis of extreme storms observed in the autumn–winter periods of the early 21st century was done. The cyclone type was determined using the HYSPLIT (Hybrid Single Particle Lagrangian Integrated Trajectory Model), which makes it possible to reconstruct the trajectory of the approach of the atmospheric vortex to the coast. The seasons with clusters of storms were identified, when deep cyclones affected the coasts of the Kaliningrad Region in a relatively short time. Regardless of the type of trajectory, storms cause destruction of both natural and infrastructure objects. But the shores of the northern exposure are most susceptible to destruction by “diving” cyclones, the wave regime of which has a high potential energy. Earlier it was noted that the frequency of cyclones with northerly winds increases. Clusters of northern cycl

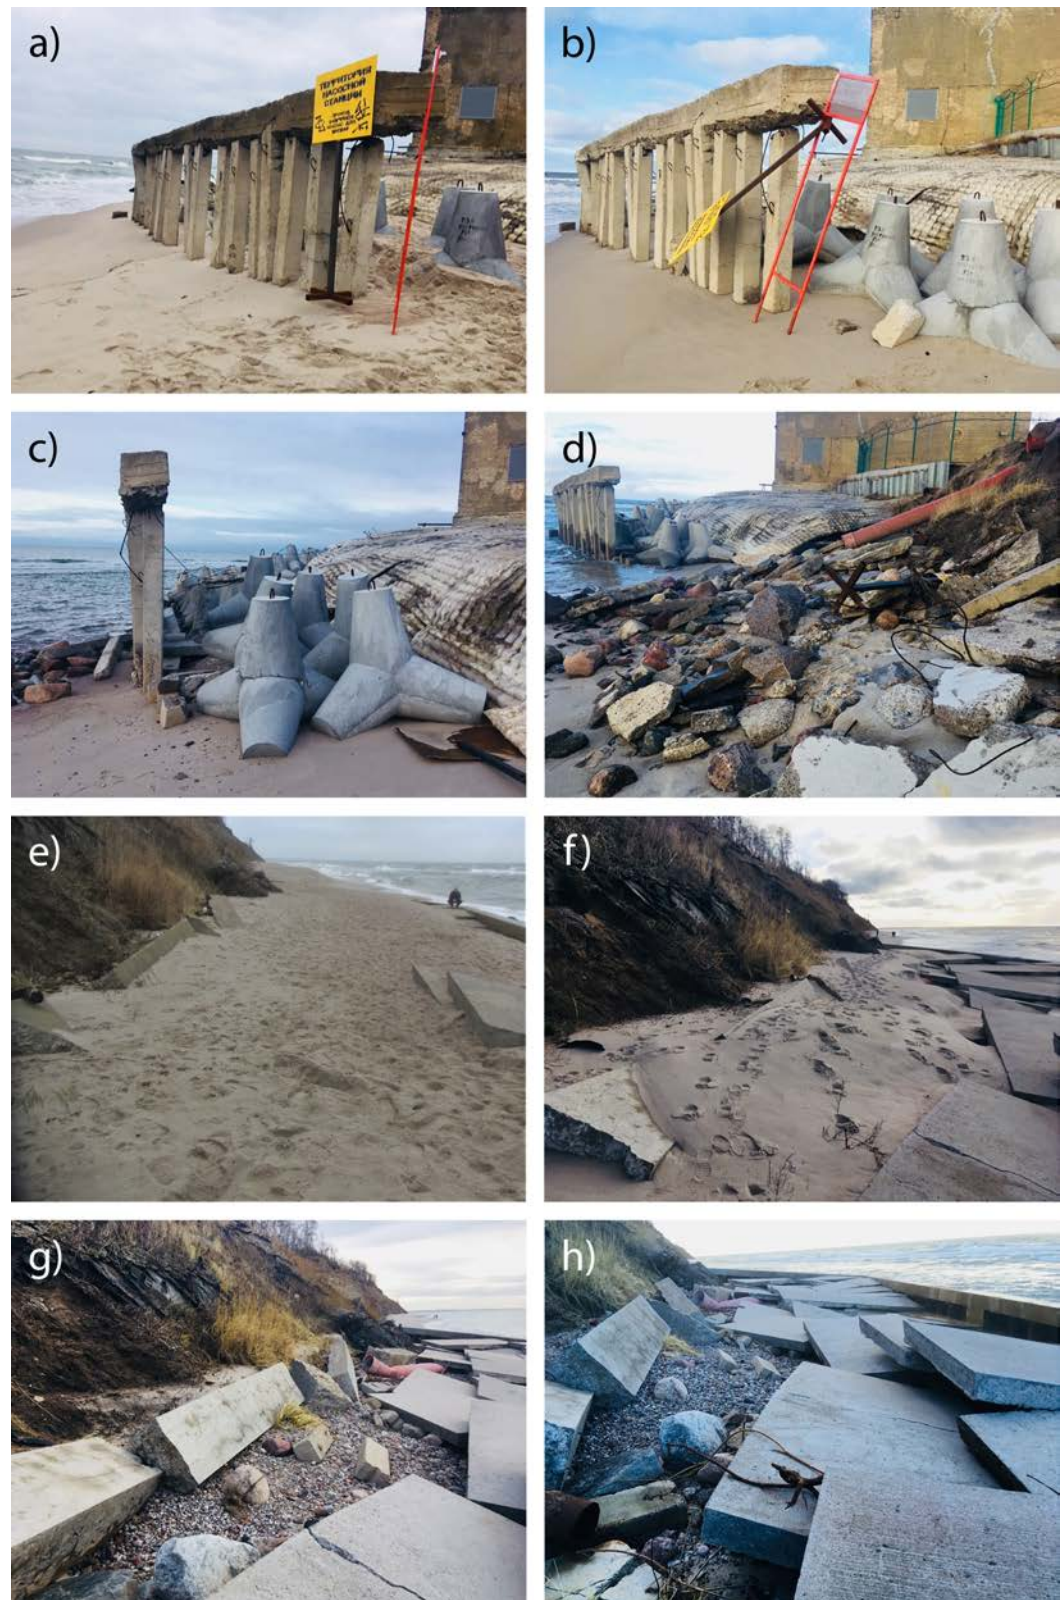
Figure 3. Dynamics of the destruction of engineering structures and the slope in the village Yantarny: (a–d) at the pumping station; (e–h) – near the bank-protective retaining wall: (a) and (e) – January 4, 2022; (b) and (f) – January 18, 2022; (c) and (g) on January 23, 2022; (d) and (h) on February 11, 2022.

- in the village Pokrovskoye was broken and the slipway for boats collapsed;
- in the southern part of Yantarny, sections of the retaining wall were washed away and collapsed, and on both sides of it, the cliff bank was partially collapsed; in the protective coastal structure near the pumping station of the amber plant, the geotextile cementing shells (slabs) of BetoBOX, the girdle and the newly erected structure of shaped blocks (tetrapods) were displaced and deformed (Figure 3). In the northern part of Yantarny, in the area of the Blue Flag beach, infrastructure facilities, non-stationary buildings, and wooden flooring were damaged or completely destroyed;

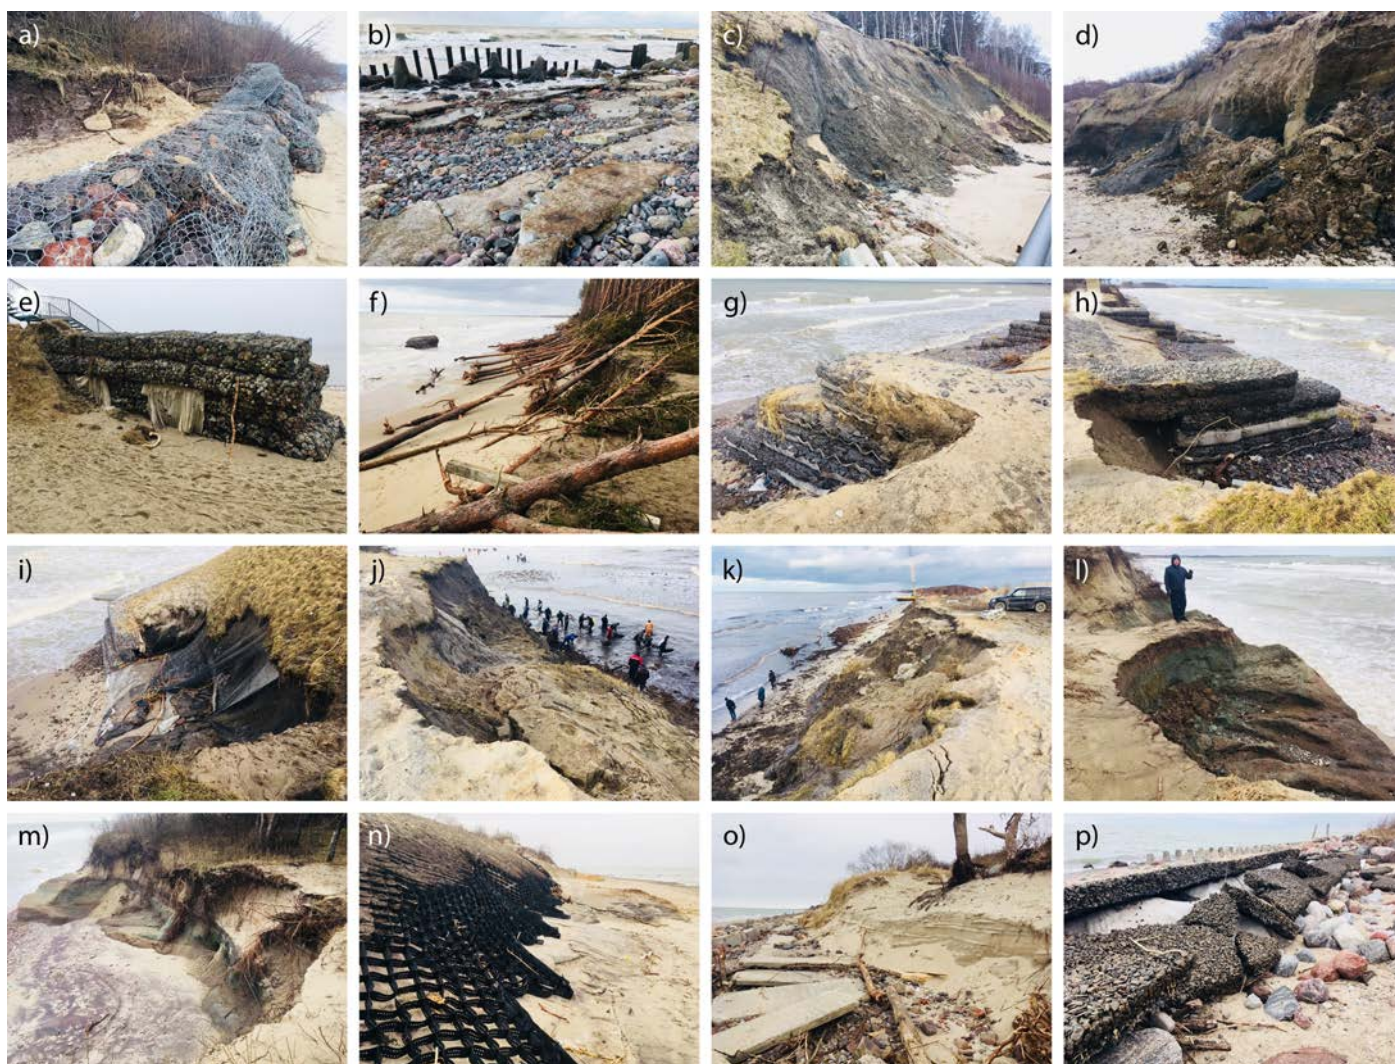
Figure 4. Erosion of the shores of the northern coast of the Sambia Peninsula: (a) Svetlogorsk city on February 15, 2022; (b) Svetlogorsk city on January 31, 2022; (c) Pionersky city on February 25, 2022; (d) village Zaoostrovye February 12, 2022, (e) village Zaoostrovye February 7, 2022, (g) Kulikovo February 1, 2022, (h–k) village Roshchino February 1, 2022, (l–m) village Sokolniki May 2, 2022, (n) the western beach of Zelenogradsk February 2, 2022, (o–p) the root of the Curonian Spit September 3, 2022.

- from Cape Taran, the entire northern coast of the Sambia Peninsula was marked by sea erosion of coastal cliffs, erosion of the native coast with landslides and tree collapse (Figure 4);

- in the area of the village Otradnoye, active erosion of the coastal cliff was accompanied by the collapse of extended sections of the piled concrete belt. In the city of Svetlogorsk, in the western part of the beach, along a stretch of several tens of meters, gabion structures (built as supports for crumbling cliffs) collapsed along with slope erosion and landslides (Figure 4a). In the cities of Svetlogorsk and Pionersky, promenades were damaged (staircases, sections of fences and handrails, embankment coverings, retaining walls made of gabions, a technical road made of concrete slabs) (Figure 4b, c);

- in the section from Pionersky to Cape Gvardeisky, the slope receded by 1–4 m with the destruction of part of the pine forest (Figure 4d). In the village Zaoostrovye the gabion retaining wall at the base of the slope (built in 2016) did not save the cliff behind it from collapse (which had already been partially damaged during the *Alfrida* storm in 2019). The slope receded from the base of the gabion by more than 8–10 m, completely exposing the side and rear parts (by 6–8 m) of the already moving and

- lopsided protective structure (Figure 4e). At the stairway above the gabion, the *Ida* storm swept away several lower flights of stairs and twisted the concrete base;

- in the village Kulikovo, in the back part of the constructed bank-protective piled concrete belt with stone boulder fill (construction in 2020), the formed slope subsided with the exposure of the geotextile substrate. At the new slipway for boats, the soil was washed away and the boulder riprap was destroyed. A significant part of the pine forest was destroyed with the collapse of dozens of trees onto the beach; in some places the slope receded by 3–5 m. Inside the remaining narrow forest belt, there was a pile of uprooted and broken pines (Figure 4f);

- east of the village Kulikovo (village Roshchino) two coastal protection structures were damaged. On both sides of the bank-protective retaining wall made of gabions (in the design of 2018, box-shaped and mattress gabions), erosion of the slope was formed to a depth of more than 2–3 m, exposing the base, side and rear parts of the structure (Figure 4g, h). The second bank protection structure (~200 m east of the first structure), built in 2018, which has a complex multi-layer structure (geotextiles, geomats, geogrids, big bags, metal meshes, gabions), was severely destroyed along the line of contact with the collapsed slope, survived only gabion wall, behind which deep dips of 2–3 m were formed (Figure 4i). Buried concrete slabs with protruding metal rebar and heaps of woven Big Bags (or FIBC Big Bags) were exposed in front of this bank protection facility. Throughout the entire area, a system of cracks formed parallel to the cliff, followed by soil slippage and the formation of landslide ledges up to 2–4 m (Figure 4g–k);

- at the village Sokolniki, the toe of the slope washed away, followed by the collapse of the low cliff. Pointwise, the slope receded to 2–5 m (Figure 4l, m), the edge of the foredune was eroded, and a 1.5–2 m high erosion ledge was formed;

- in the western part of Zelenogradsk, the slopes of the foredune reinforced with geosynthetic materials were damaged (Figure 4n). The central part of the promenade, flights of stairs, the construction site of the cafe, as well as the wooden promenade and wooden slopes to the sea (opposite the city park) were damaged, the edge of the foredune was washed away with the formation of a washout ledge of more than 3 m (the edge of the foredune receded by 1–2 m), and a new slipway and infrastructure elements were damaged near the cemetery. There was a breakthrough of the foredune in the root part of the Curonian Spit, both the old bank protection structures and the newly built ones were damaged (with collapse in the rear part of the structures) (Figure 4o, p). In the village of Lesnoye on the Curonian Spit, the slope of the foredune receded by 2–5 m. The wooden promenade and coastal infrastructure facilities were damaged.

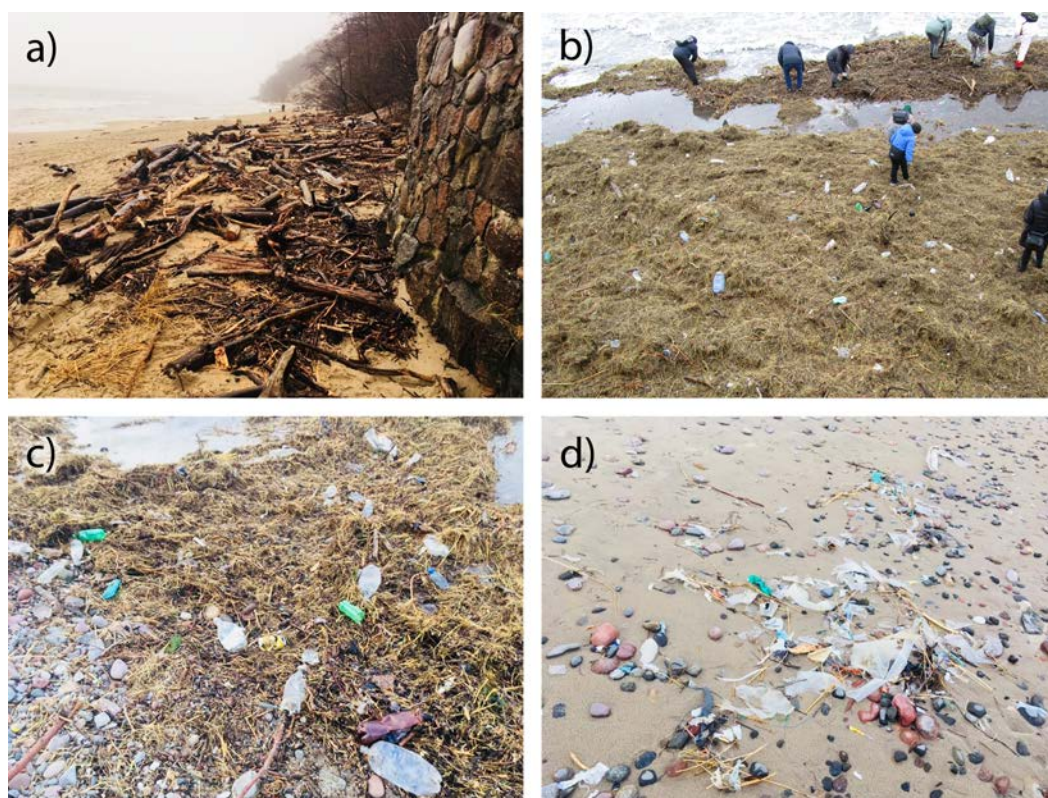
Figure 5. Storm discharges onto beaches containing plastic debris: (a) village Otradnoe January 27, 2022, (b) Zelenogradsk (city beach) February 2, 2022, (c, d) village Sokolniki May 5, 2022.

After the passage of *clusters* of strong storms in the autumn–winter period on the shores of the Kaliningrad Region, erosion of the bases of cliffs and foredunes is observed everywhere, followed by the strongest collapse of slopes, landslides, the formation of erosion ledges up to 2–3 m, slope retreat up to 1–5 m, damage or destruction of coastal protection structures and objects of coastal infrastructure. All deformed coastal protection structures turn out to be a source of emission and pollution of beaches with geosynthetic materials that were part of their structures (geocells, geomats, bags and big-bag containers, geotextiles, fragments of plastic-coated metal meshes from broken gabions, fragments of BetoBOX shells, waterproofing film, fragments technical interlayers made of expanded polystyrene, etc.) [Esiukova et al., 2018]. It should be noted that in the inter- and post-storm period, all the beaches were covered with a huge amount of grass from eroded slopes, branches and uprooted bushes, algae, wood chips and fragments of wooden piles, and tree trunks. But all these biological ingredients of post-storm erosion of slopes were mixed with mega-, macro-, meso-, micro-debris with a predominance of the anthropogenic component – plastic (Figure 5), which leads to new environmental problems [Chubarenko et al., 2022, 2018; Esiukova, 2017; Esiukova et al., 2018].
