Obrabotka metallov (tekhnologiya, oborudovanie, instrumenty) = Metal Working and Material Science. 2025 vol. 27 no. 4 pp. 287–308 ISSN: 1994-6309 (print) / 2541-819X (online)

### Study of abrasive wear resistance of flux-cored wires during surfacing on high-manganese Hadfield steel

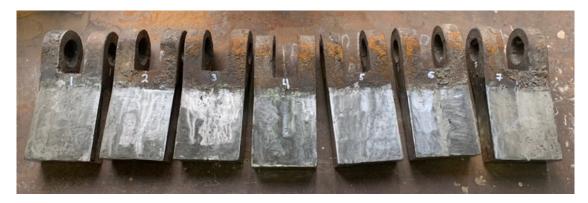
Fig. 3. Visual inspection of the beater surface after removal of metallurgical slag

A milling operation of the working surface was performed to a depth of 10 mm. Extensive through-hole defects were identified on two hammers (No. 1 and 3). Subsequently, new hammer samples were selected for surfacing, which successfully passed visual and capillary control.

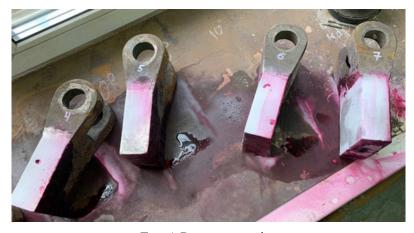
Fig. 4. Penetrant testing

Visual and penetrant testing of the seven received products revealed the defects listed in Table 4.

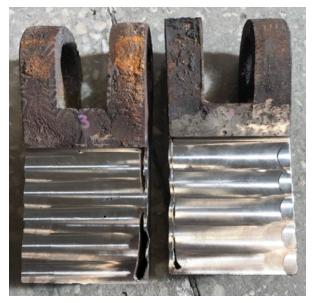
Fig. 5. Extended through-thickness defects on the beater, numbered 1, 3 (see Fig. 3)

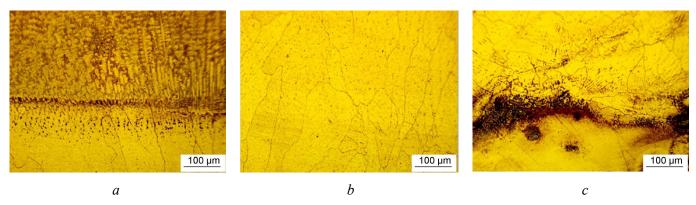
Fig. 7. Microstructure of the surfaced layer with a buffer layer:

a – surfaced layer at the boundary with the buffer layer; b – buffer layer; c – transition layer between the buffer layer and 1.1% C-13% Mn steel

The microstructure of the surfaced layers is shown in Figs. 7–8. The structure of the surfaced metal contains boron carbides (Figs. 8, a, b) and chromium carbides (Figs. 8, c, d).

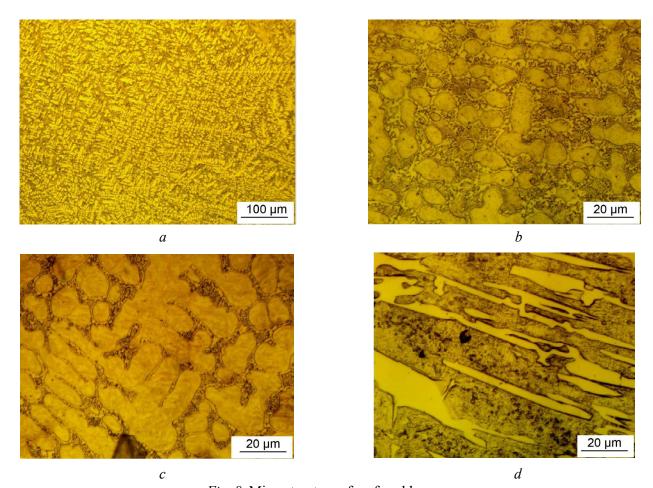
Fig. 8. Microstructure of surfaced layers:

a – surfaced layer with ASM 57 – OA wire; b – surfaced layer with CARBO AF D600 wire; c – surfaced layer with TD-RC3 wire; d – surfaced layer with TD-600 wire

Studies have shown that the microstructure of the surfaced metal is based on martensite and carbides of the  $M_3C$ ,  $M_7C_3$ , and  $M_{23}C_6$  types. Borides are observed in the microstructure of the deposit from ASM 57-OA wire (Fig. 8, a). The high carbon content in the wires ASM 57-OA, TD-RC3, CARBO AF D600, and K-600NT promotes the formation of a martensitic matrix with inclusions of y (Fig. 8, a). The martensitic microstructure is often chosen for its excellent abrasion resistance and satisfactory impact toughness.

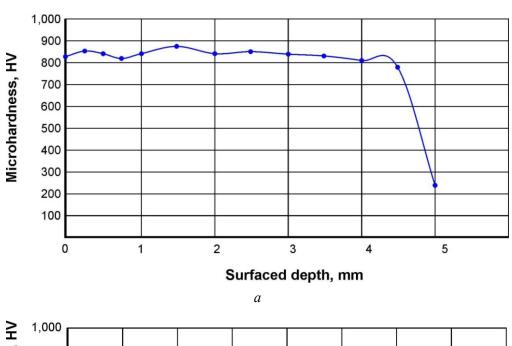
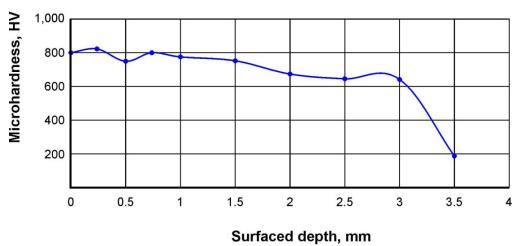
Fig. 9. Microhardness profiles across the surfaced depth: a - K-700NT wire; b - TD-600 wire

These values are significantly higher than those of the Hadfield steel substrate, which measured 258 HV. The microhardness profile measured through the depth of the coating is shown in Fig. 9. The depth of the surfaced layers is 3–4 mm. The hardness in the middle of the coating averaged 750 HV, while the highest hardness values were recorded in the top layer of the coating. Figure 9 shows a peak microhardness of 900 HV for two samples. The higher hardness of the coating is attributed to the formation of a large number of primary  $M_7C_3$  carbides and may also be associated with the martensitic phase. In the case of the TD-RC3 wire (Fig. 10, b), the hardness is lower, which correlates with a relatively lower concentration of elements such as Cr and C in the surfaced metal. Thus, it can be inferred that the type, size, shape, and distribution of carbides, as well as the matrix structure, strongly influence the hardness of the surfaced layer.

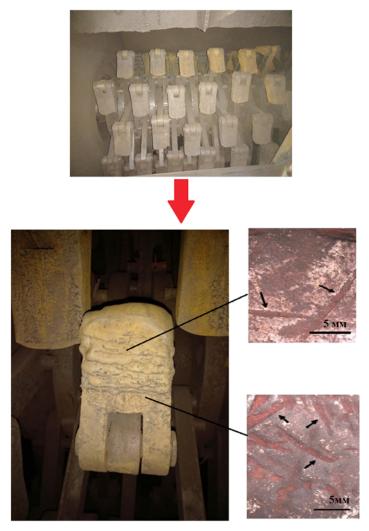
Fig. 13. Inspection of welded beaters after 466 hours of testing

Subsequently, a batch of 12 hammers (Fig. 11), surfaced with K-700NT wire, was installed on the MMT-1A mill. The remaining rows were fitted with standard, non-surfaced 110G13L steel hammers in the quantity of 114 pieces (Fig. 12). After 466 hours of testing, an inspection was conducted (Fig. 13). Following this inspection, testing was continued until the hammers were completely worn out.

Fig. 13 shows the worn surface of a crusher segment (upper part) examined using a stereo microscope. Deformation marks are clearly visible during macroscopic examination. These marks resemble wear patterns resulting from significant particle impacts on the surface. The authors of [22] classified wear caused by repeated solid particle impact as impact wear. However, the synergistic effect between impact and abrasion, referred to in the literature as impact-abrasion, has been described by several authors [12–20]. The observed damage mechanisms on worn hammers operating on coal ash led us to conclude that impact damage mechanisms, synergistically interacting with abrasion mechanisms, create resultant wear rates exceeding the sum of individual components, consistent with the results of other work [16–23]. It is important to emphasize that the observed wear features (see Fig. 12) exceed the material's grain size, suggesting that the material removal process occurs on a millimeter scale. Therefore, given the nature of this phenomenon involving the grinding of abrasive coal fragments and impact between metal bodies, the term "impact-abrasive wear" better describes the mechanism considered in this study.
